Defence
Safety
Authority

Service Inquiry

HERCULES C-130J Mk4
(ZH873) Heavy Landing
Incident

25 August 2017

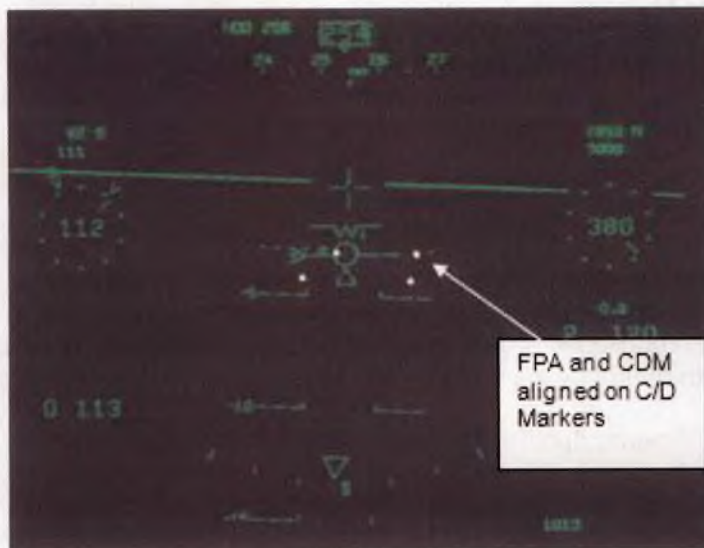
Figure 15 – Aiming at the front of the Touchdown Box

1.4.219. Testimony from both pilots, indicates that the handling pilot was aiming at the front of the Touchdown Box, which was not in accordance with the ACM. As is further discussed at paragraph 1.4.553, the PF indicated that his recent experience of lighter aircraft in the training environment was of a tendency for aircraft to 'float' and touch down towards the back of the Touchdown Box. His selection of an aiming point shorter than mandated reflected his desire to avoid missing the Touchdown Box or floating down the runway, and having to initiate a Go-Around.

1.4.221. Had the PF aimed into the Touchdown Box, the Panel assessed it as almost certain that ZH873 would have landed 150 ft further forward than it did. At the very least this would have been beyond the 4° slope, and extremely likely to have been on the 300 ft of prepared overrun surface rather than 100 ft short of it. This would almost certainly have resulted in less structural damage to the aircraft (see paragraph 1.4.232 et seq).

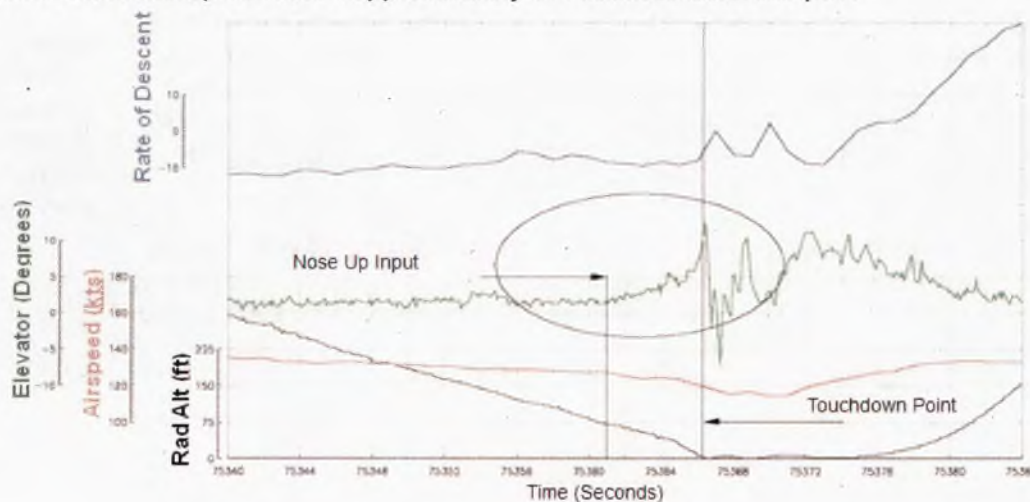
Figure 18 – Increase in Elevator Angle

1.4.226. Figure 18, a DFDR trace of ZH873's flare, shows a gradual nose up input (increase in elevator angle) approximately 5 seconds prior to impact, followed by an increased nose up deflection approximately 0.4 seconds before impact.

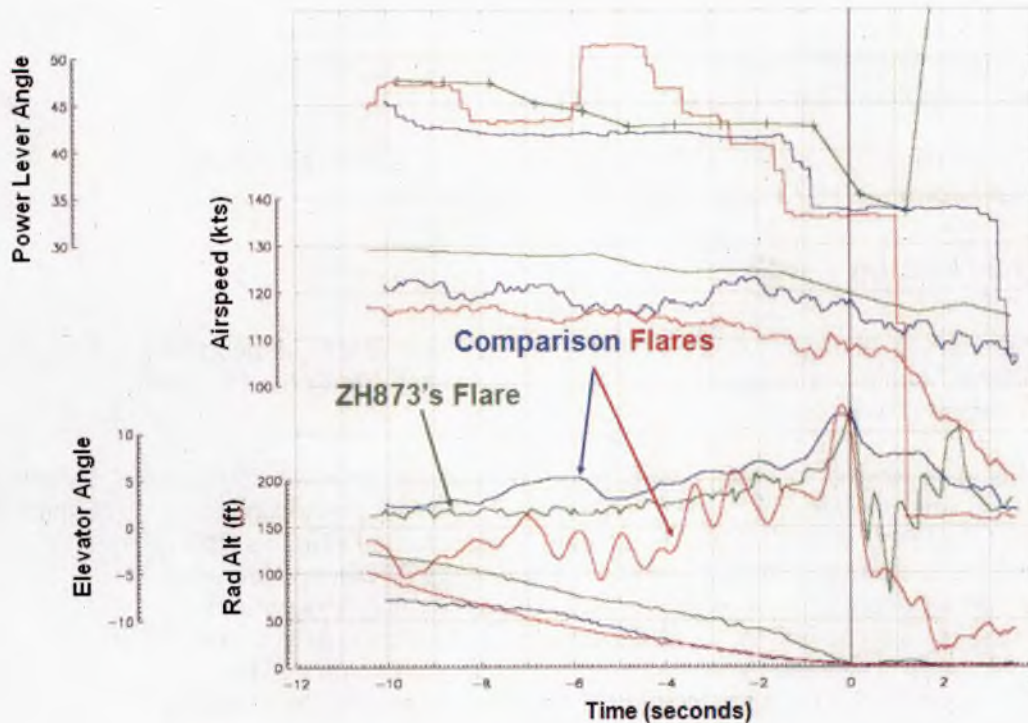
Figure 19 - Flare Comparison – ZH873 and NSO Trial Data

1.4.227. ZH873's flare was compared with data gathered during NSO trials (Figure 19). In each case the initial part of the flare is very similar, ie at about 5 seconds prior to touchdown a gradual nose up elevator input is initiated. However, ZH873's trace shows that the final elevator deflection is later than the other 2 approaches, and ZH873 appears to have touched down before its flare was completed, ie the aircraft impacts the ground while the elevator input is still being increased. This would have affected the reduction in the rate of descent and achievement of the full flare distance expected.

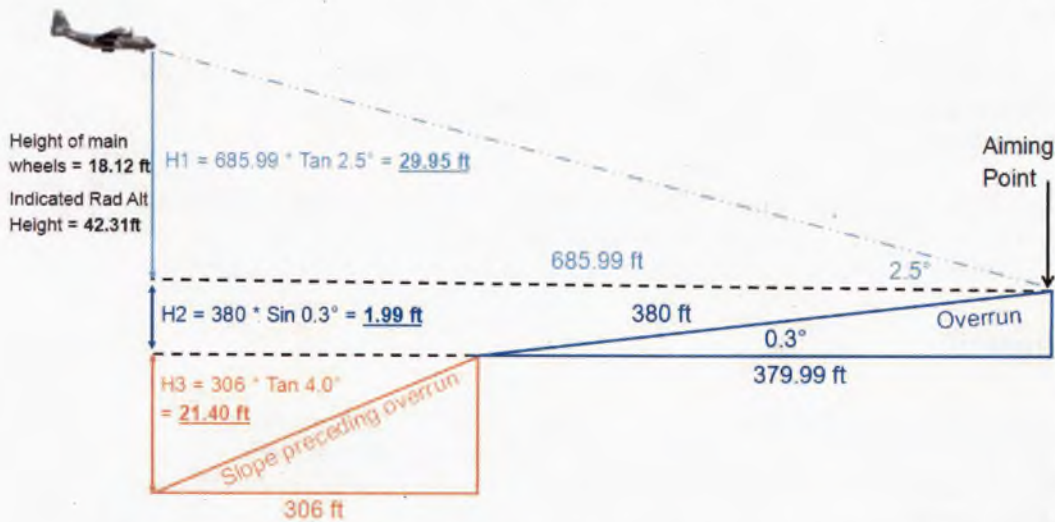
Figure 26 – Rad Alt Height Reading as ZH873 Crossed Start of Slope (Not to scale)

1.4.303. The TLZ ZH873 was approaching is positioned at the top of gently rising terrain, and is preceded by a significant slope immediately before the overrun surface (paragraph 1.4.113); as such the Rad Alt readings would have been greater than the aircraft's actual height above the runway threshold. This is illustrated in Figure 26:

1.4.304. As ZH873 crossed the start of the slope prior to the runway, the pilot's eye would (theoretically) have been 29.95 ft above the Aiming Point (H1 in Figure 26). By extrapolation, using the Eye to Wheel Height of 11.83 ft, the main wheels, are 18.12 ft

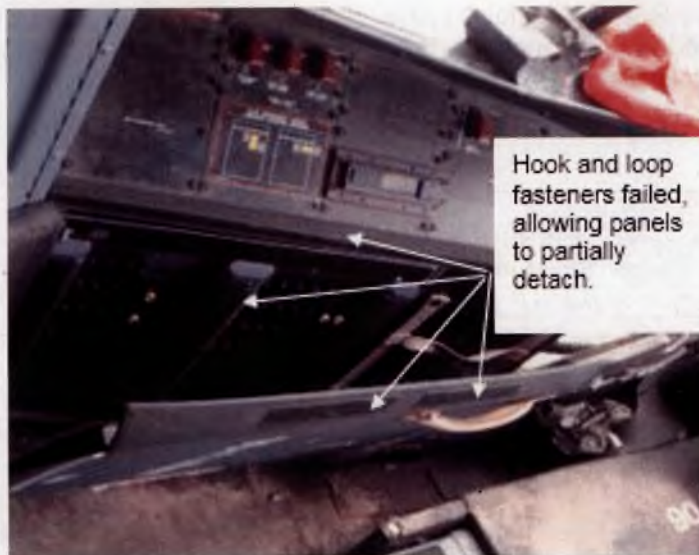
Figure 29 - Circuit Breaker Armour Panel partially detached.

- a. Circuit Breaker Armour Panels located beside the pilots' seats partially detached, obstructing the escape pathway to be taken in an emergency evacuation - Figure 29.

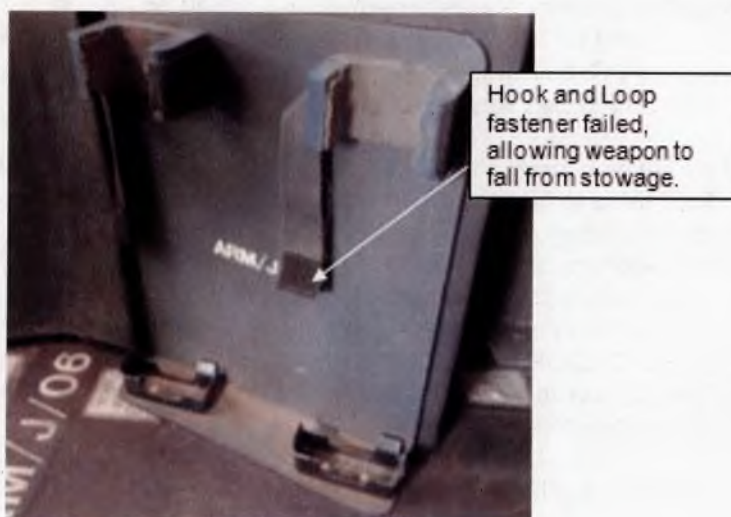
Figure 30 - Weapon Stowage Hook and Loop retaining strap fastener failed

- b. One weapon became dislodged from its stowage as the hook and loop retaining strap failed, resulting in further obstruction of the emergency egress pathway (Figure 30). This is subject to the same testing and servicing regime as the armour panels.

1.4.382. Examination by RAF CAM showed ZH873's hook and loop fasteners were contaminated and ingrained with dirt and dust; in load testing, the Weapon Stowage retaining straps and co-pilot's Circuit Breaker Armour Panel failed to achieve the minimum shear force required (which should be in excess of 35 lbs), as shown in Table 12.

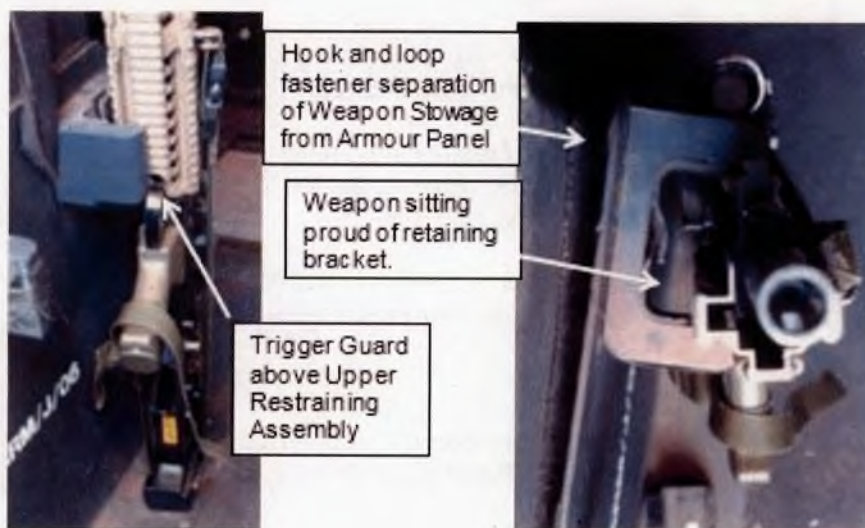
Figure 33 - Partially Secured Rifle

1.4.391. Although a Panel member was able to fit a weapon into the stowage, this was only achieved by placing significant upward and outward pressure on the upper securing assembly. As a consequence, the tendency is for the rifle to be only partially placed into the stowage, as indicated in Figure 33; not only did this reduce its security, it exacerbated the tendency of the weapon's weight to pull the top of the stowage away from the armour panel behind it.

1.4.393. The Panel determined that the Weapon Stowage utilised on the flight deck, being designed for the L85A1/A2 (SA80), is incompatible with the L85A2 (SA80) Theatre Entry Standard rifle.
